Driver's Injury Severity in Light N1 Vehicles Derived from Crash Test

M. H. Johari^{*1,2}, Y. Ahmad², S. S. S. Zainuddin³, J. M. Jyothesh⁴, N. K. Khamis¹ and M. R. A. Mansor¹

ABSTRACT – Light N1 vehicles, also known as Light Commercial Vehicles (LCVs), of two types are being considered for this study: panel vans and small lorries. This paper presents the causes of driver injury in light N1 vehicles derived from official ASEAN NCAP crash test data. Companies employ all sorts of vehicles to help expedite the delivery process, but having considered the large amounts of orders globally, keeping costs low is also of top priority. To overcome this problem, companies now employ the use of LCVs, which not only are smaller in size allowing them to maneuver through small lanes easily but are relatively inexpensive to run in comparison to their larger counterparts. LCVs fall under the N1 category of vehicles which is an EU classification of vehicles that are used to carry goods of maximum mass not exceeding 3.5 tons and they commonly can be found carrying goods either on the exposed cargo trunk or within a compartment at the rear of the vehicle. However, the structural integrity and crashwo

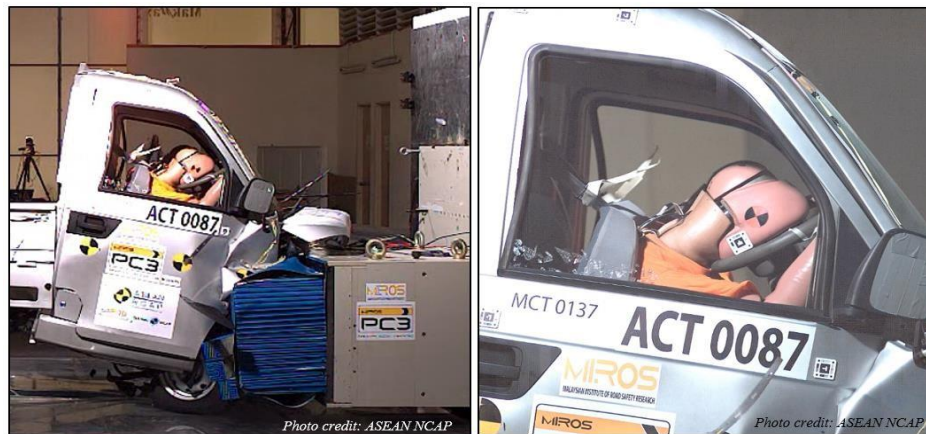
FIGURE 3: Chery Transcab image at $t = 0.1\text{ms}$ during impact with driver close-up view

Figure 3 shows the deformation of the frontal structure of Chery Transcab during impact. 50% of the driver's survival space had been destroyed. The intrusion into the cabin was extensive resulting in higher injuries to the dummy's legs. The injury value for the upper tibia index is 1.36 for the right and 0.96 for the left tibia. The lower tibia index was 0.96 for the right and 1.06 for the left. The figure also depicts the initial contact between the dummies and the steering. Observations show that upon impact the dummy's head thrust towards the steering wheel and the lack of an airbag caused severe head injury resulting in the HIC15 value to be 595.61 and resultant acceleration at 3m/sec to be 80.53G.

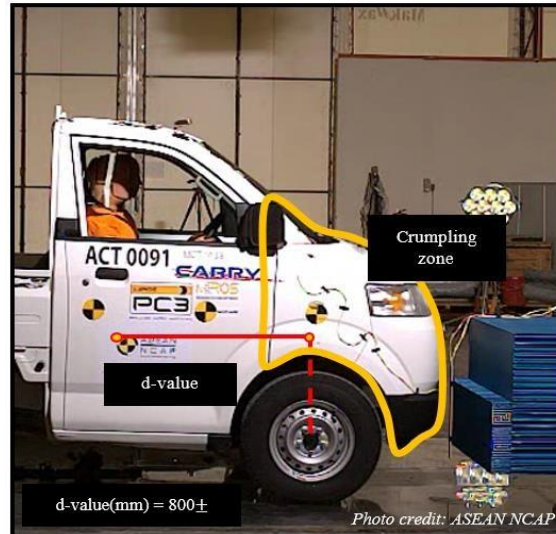
FIGURE 4: Pre-crash image of Suzuki Carry

Figure 4 shows the frontal design structure of Suzuki Carry. When compared with other N1 vehicles that have been tested, Suzuki Carry has the largest crumple zone, which is assigned as the yellow region, as well as the largest d-value at $800\pm\text{mm}$.

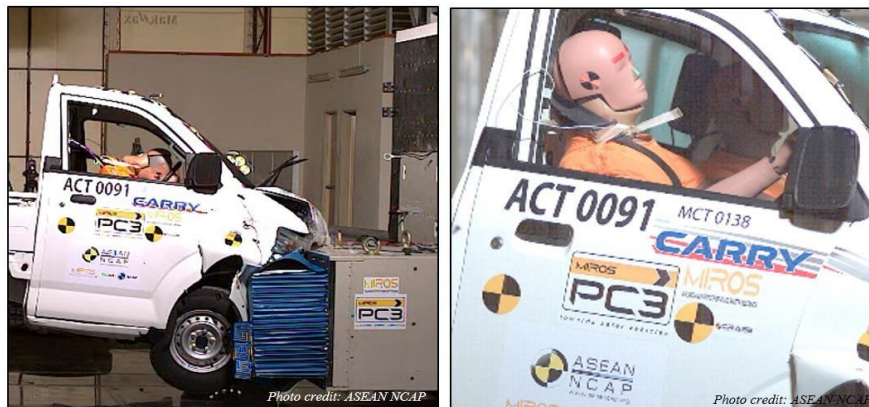
FIGURE 5: Suzuki Carry image at $t = 0.1$ ms during impact with driver close-up view

Figure 5 shows the results of the crash test on Suzuki Carry. The head of the dummy nearly came in contact with the steering wheel as the seatbelt held the dummy well. This also proves that a larger crumple zone can absorb the energy and transfer it throughout the vehicle better. We can see that the dummy's position concerning the door frame, steering wheel, and panel after the crash test indicates that the driver's crumple zone was maintained reasonably well. The dummy only happens to have a slight chest compression of 35.65mm. Moreover, intrusion into the driver's space was minimal, and all leg and foot-related injury measures were low. Figure 5 also shows the dummy's head hit the B-pillar of the truck during rebound. Having only a slight hit to the B-pillar as well as zero contact with the steering wheel, the head injury value of the dummy in Suzuki Carry was low. The resultant acceleration and HIC15 are 72.18G and 395.37 respectively. This allows a conclusion that having a larger d-value benefits occupants in terms of collision safety, restricting the driver from having contact with the steering wheel or the front compartment and also maintaining a safe distance when a crash occurs.

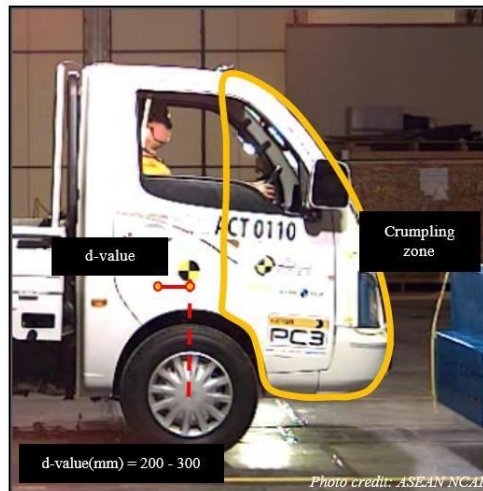
FIGURE 6: Pre-crash image of TATA Super Ace

Figure 6 shows the condition of the Tata Super Ace before the crash test. When compared to the other model of the N1 vehicle, the TATA Super Ace has the smallest d-value between the front axle and the driver's seat which is between 200mm to 300 mm. From initial visual analysis, it can be seen that the

driver's leg was placed within the crumple zone (yellow area). The design of the TATA Super Ace is particularly not safe as the dummy position was mostly in the survival space.

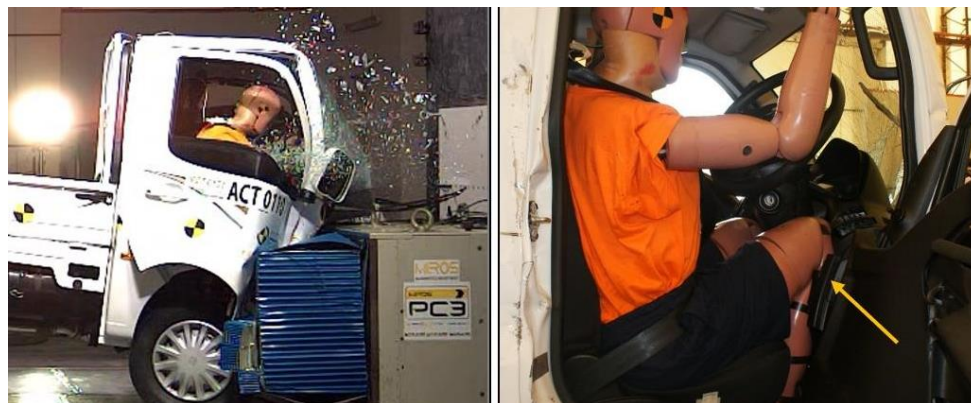
FIGURE 7: TATA Super Ace image at $t = 0.1$ ms during impact and dummy post-crash position

Figure 7 shows the action shot during the $t = 0.01$ ms of impact. It can be observed that the driver's survival space or the crumple zone did not sustain the impact well. The impact had destroyed approximately 86% of the residual space. Observation shows that upon collision the dummy's head thrust towards the steering wheel and the lack of an airbag caused severe head injury during impact. As seen from Table 5 the HIC15 value is 839.78 and the resultant acceleration is 85.4G. There was small compression to the chest (33.48mm) due to the impact of the steering wheel and compression of the seat belt. Figure 12 shows the post-crash view from the driver's side. Due to the driver's seating position being in the crumple zone and smaller d-value, the intrusion of the frontal compartment consequently trapped both dummy's legs. The highest injury value of the tibia index was recorded as shown in Table 5. For the right leg, the upper tibia index is 1.65 while the lower tibia index is 2.13. For the left leg, the upper and lower tibia index are 2.62 and 0.93 respectively.

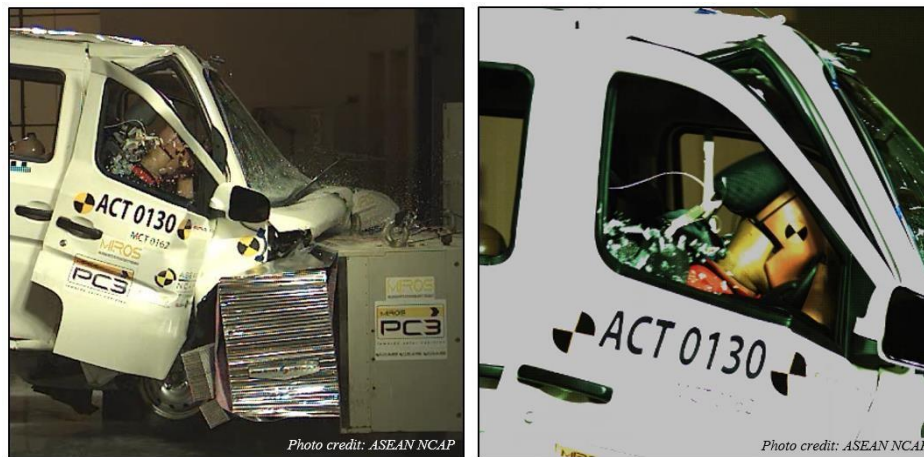
FIGURE 9: Chana Era Star II image at $t = 0.1\text{ms}$ during impact with driver close-up view

Figure 9 shows the action shot taken during the driver-side offset frontal crash test at $t = 0.1\text{ms}$. As seen in the figure, can be observed that the frontal structure of this model was unable to withstand the impact well. The driver's survival area has lost 80% of its initial compartment. Both the door frame and the A-pillar are seen to have deformed extensively. Further study on the dummy had shown that, upon impact, there was a direct collision between the dummy's head and the steering wheel. This, along with the movement of the driver seat forward from its initial position, has caused the dummy to be trapped in a very tight space. This test shows that the lack of an airbag has severely impacted the dummy causing the head to collide with the steering. Thus, the chances for the head to collide with any stiff structure (under various conditions) are high. The value of resultant acceleration was at 3m/sec and HIC15 for this model is 98.37G and 560.1, respectively.

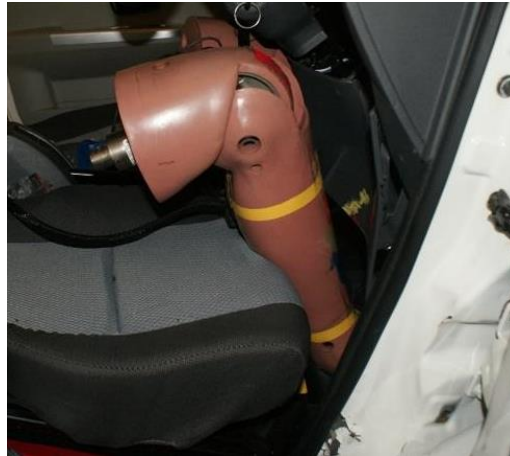
FIGURE 10: Post-crash tibia position

Figure 10 shows the impact on the legs as a result of the massive intrusion into the driver's cabin. The driver's lower extremity had sustained severe injuries with the upper tibia index value recorded at 0.57 and 1.69 for the right and left respectively followed by a lower tibia index of 0.30 and 1.73 for the right and left respectively. The obtained values were above the NCAP threshold limits.

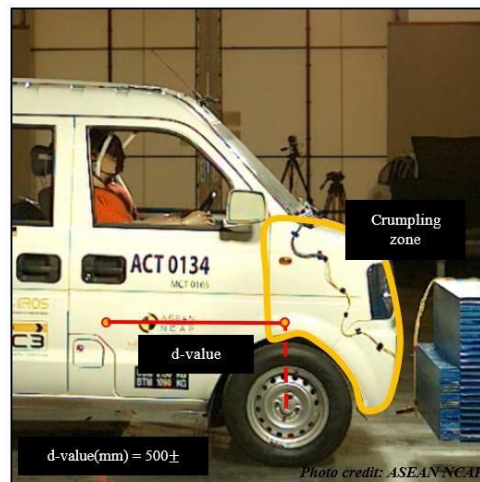
FIGURE 11: Pre-crash image of DFSK V25L

The DFSK V25L is a semi-panel van that was built and produced in 2019. The design of DFSK V25L in Figure 11 is found to be like that of the Chana Era Star II. The frontal structure of the DFSK V25L is commonly addressed as a semi-flat-head design. The d-value for this model is found to be $500\pm\text{mm}$. Similar to the previous tested models, the crumple zone had been indicated with the yellow line, and with a closer study the crumple zone of the DFSK V25L is found to be smaller than that of Chana Era Star II, which from a visual analysis standpoint, seem insufficient to effectively absorb and distribute the energy from the impact.

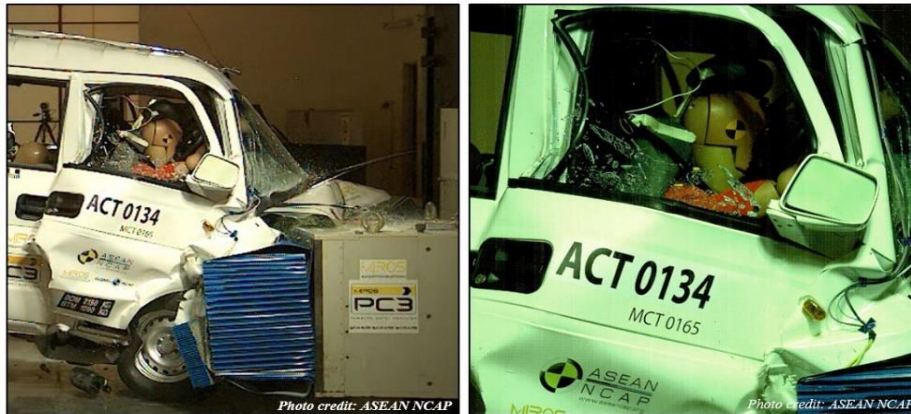
FIGURE 12: DFSK V25L image at $t = 0.1$ ms during impact with driver close-up view

Figure 12 shows the action shot taken during the offset frontal crash test on the driver's side. Just like the previous model tested the front of the vehicle was unable to maintain its structural integrity which had further impacted the door frame and the A-pillar. Further study of the body structure has shown that the severity of the impact was due to the smaller crumple zone region, causing an inefficient energy distribution throughout the vehicle.

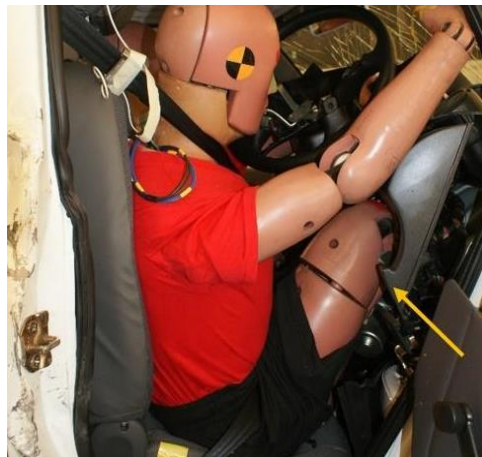
FIGURE 13: Post-crash image of DFSK V25L driver

Figure 13 shows the condition of the dummy from within the cabin after the crash test. The effects of impact had severely compressed the cabin space trapping the dummy between the steering wheel and driver's seat. Observation shows that upon impact the dummy's head thrust towards the steering wheel and the lack of an airbag caused severe head injury. The HIC15 value was recorded as the highest at 1,358 while the resultant acceleration at 3m/sec was 141.51 G. From Figure 13 we can also see the dummy's leg is trapped within the compartment causing injuries to the tibia. As shown in Table

5 above, the upper tibia index value is 0.57 on the right and 0.34 on the left. The lower tibia index is 0.30 and 0.31 for the right and left respectively.

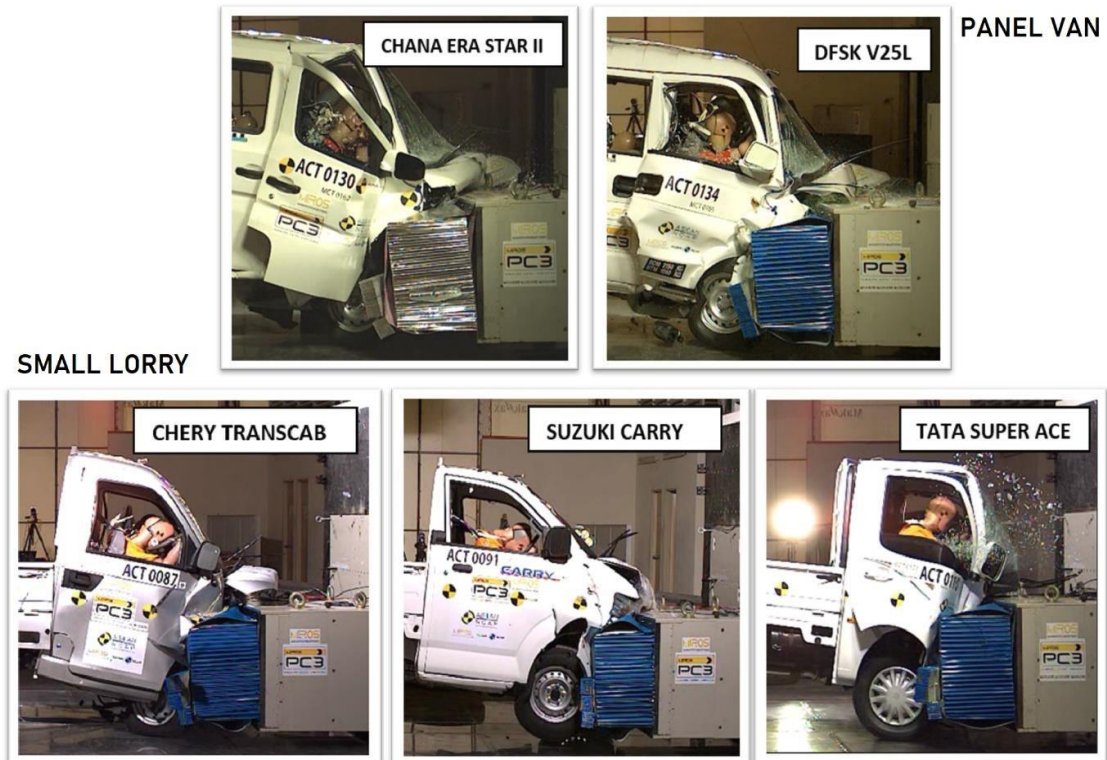
FIGURE 14: Light N1 vehicle crash tested by ASEAN NCAP

Figure 14 shows the result of the N1 vehicle crash test by ASEAN NCAP, of all five models. It can be seen that the percentage of intrusion on the crumple zone is different for each model. Suzuki Carry was recorded with the minimum deformation on the frontal structure. Although this was the case, all of these vehicles had obtained zero-star ratings. This has proven that the structural integrity of the front of a vehicle highly contributed to the occupant's injury.

Even though a tensile test had not been conducted on these vehicles it can be seen that the structural deformation of the five models tested vary even though the impact speed is the same. The major assumption was the level of material strength used for each model. Chana Era Star II, DFSK V25L, and Chery Transcab were from China, Suzuki Carry from Japan, and TATA Super Ace from India. The results from this research can also allow a conclusion that the model from Japan might use better materials and structural design for the chassis allowing the deformation to be within tolerable range maintaining the crumple zone reasonably well.

Based on the law of physics, after the elastic region, necking will occur to the materials of the vehicle. Wu and Xin (2008) stated that the most of impact energy is absorbed by the front of the frame. Therefore, an improvement should be made to the material used at the front frame of the N1 vehicles to compensate for the lack of safety features such as airbags. As mentioned by Kang and Kim (2015), a structure should have sufficient continuity to offer an alternative path to stability of the structure even if a vertical load-resisting element is removed. This is important to prevent progressive collapse on the front structure of the vehicle.
