Micro Surfacing Asphalt Pavement as a Mitigation Measure at Accident's Prone Area along East Coast Expressway Phase 2 (ECE 2)

ORIGINAL ARTICLE

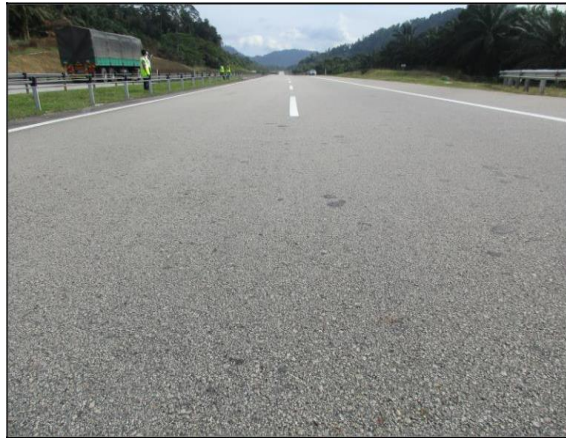
Figure 4: Ageing and polished surface of the existing pavement

This result indicated that the average Skid Resistance Value (SRV) at the accident-prone area after laying micro-surfacing had increased. The average SRV for the existing pavement surface was below 46, which means the pavement surface was not in good condition in terms of surface friction and could have caused accidents to happen, especially during wet weather. According to the Jabatan Kerja Raya (JKR), Malaysia, Standard Specification for Road Works: Flexible Pavement, clause 4.13.8.5 (2008) stated that the skid resistance value of the completed material on the carriageway should have a minimum average value of 46 as measured by the SRT pendulum device. Thus, Skid Resistance Value for micro surfacing asphalt pavement at the accident-prone areas was complying with the JKR standard (2008) and displayed an improvement in the pavement surface friction. Therefore, micro-surfacing has positively influenced the safety of driving for highway users.

Micro-surfacing asphalt pavement, which was applied to the East Coast Expressway Phase 2 as a mitigation measure at the accident-prone areas, showed impressive responses. According to the result, the analysis showed that the average Skid Resistance Value (SRV) and average Mean Texture Depth (MTD) increased after laying micro-surfacing asphalt pavement. Based on the key results of the study, the following conclusions are drawn. The rate of accidents in the accident-prone areas was reduced after undertaking mitigation measures at the site. The results highlighted that choosing micro surfacing asphalt pavement as a mitigation measure at the accident-prone areas proved to be successful and efficient, especially in saving lives by improving the skid resistance and texture depth. It is inferred that pavement surface performance in terms of friction is critical in road safety (Pranjić et al., 2020). The weather conditions are also very crucial, being one of the most dominant factors that favour the occurrence of accidents, especially in the east part of Malaysia.

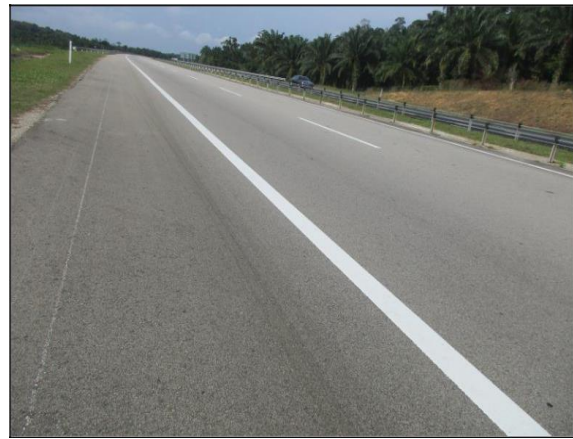
Figure 5: No Rutting or pavement undulations observed along the stretch

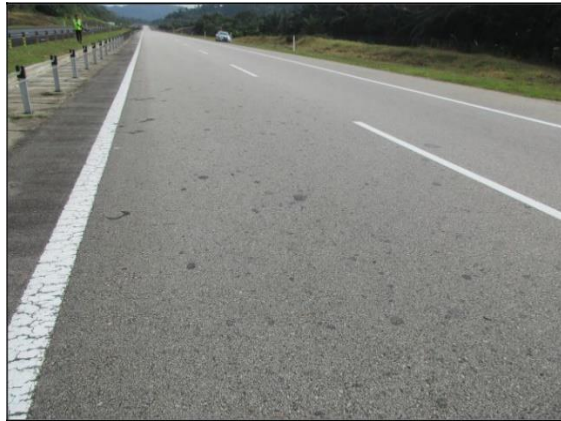
Figure 6: Ageing and polished surface of the existing pavement

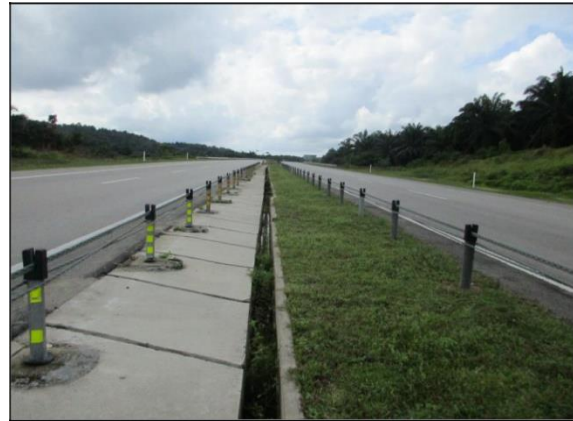
Figure 7: Proper Drainage System in the median to cater surface water runoff at KM313.7 – KM313.9 (South bound)

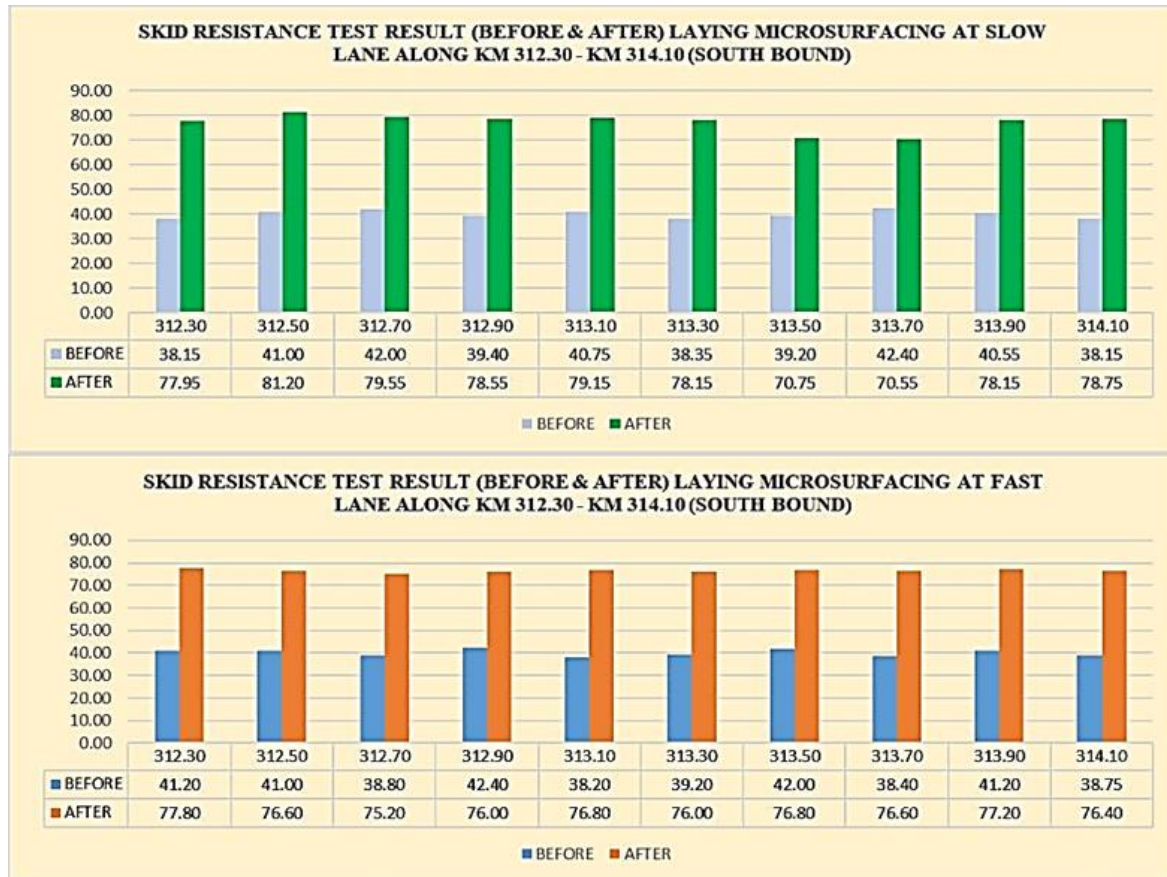
The Skid Resistance Value (SRV) was increasing in the accident-prone areas after laying micro surfacing asphalt pavement. The Skid Resistance Value (SRV) for the existing highway pavement along the carriageway at the accident-prone areas varied from 38.00 to 44.60. Then, after laying micro surfacing asphalt pavement, the SRV increased from 72.40 to 81.20. At KM312.30 – 314.10 (SB), the average SRV along the carriageway was 40.06, and after laying micro-surfacing, the value increased to 76.91 (Figure 11).

Figure 11: Skid Resistance Test result (before & after) laying Micro Surfacing Asphalt Pavement at the slow lane and fast lane along KM 312.30 – KM 314.10 (South bound)

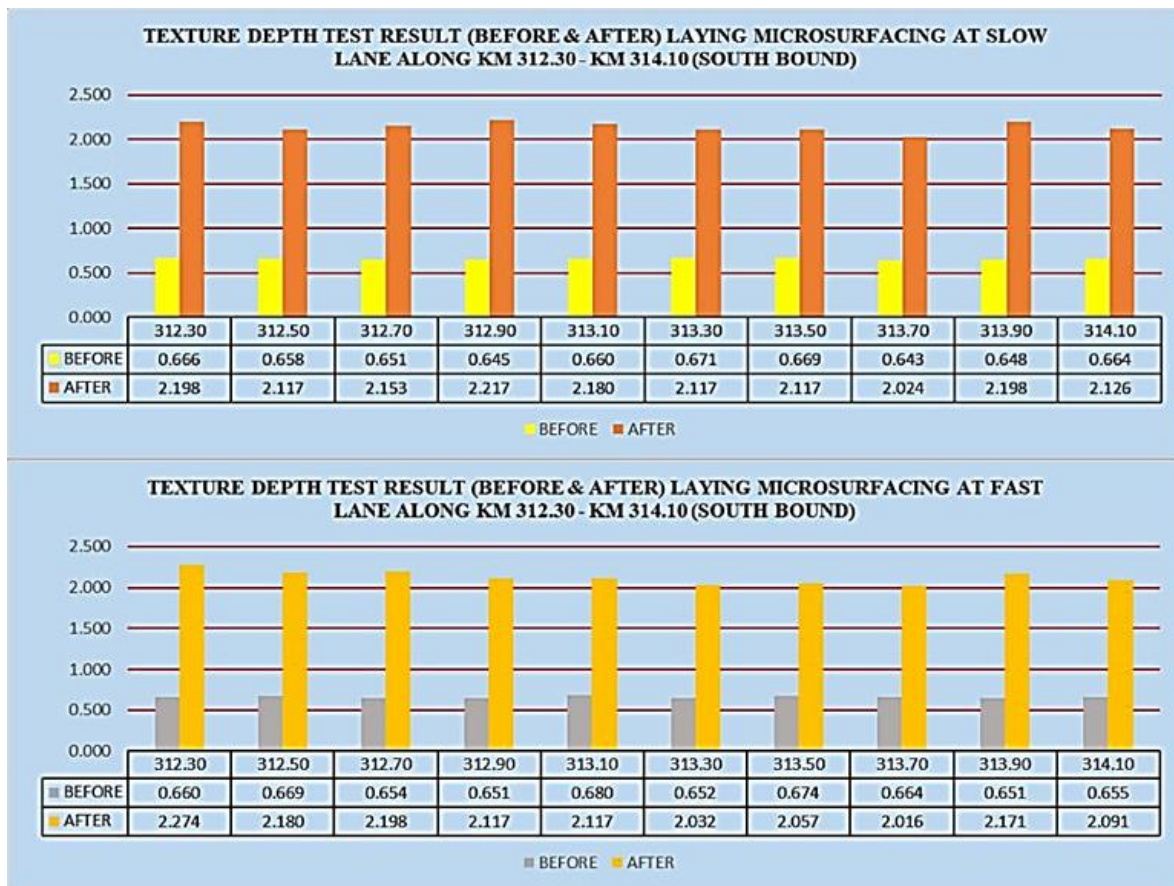
A detailed analysis of the texture depth before and after laying micro surfacing asphalt at the accident-prone areas is shown in the histogram in Figure 12. The texture depth showed an increase and improved after laying micro-surfacing asphalt pavement. The texture depth of the existing highway pavement along the carriageway at the accident-prone areas varied between 0.643 - 0.755. After laying micro surfacing asphalt pavement, the texture depth increased from 1.732 to 2.274. The analysis from texture depth test results also indicated that the average Mean Texture Depth (MTD) at the accident-prone areas after laying micro-surfacing increased considerably. At KM312.30 – 314.10 (SB), the average MTD along the carriageway was 0.659, and it increased to 2.135 after laying micro surfacing asphalt pavement. This indicated that the average mean texture Depth (MTD) for the existing pavement surface at the accident-prone areas was below 0.7, except in the stretch between KM394.40 – KM395.80 (SB). According to ASTM E955, the acceptable MTD for a heavy traffic road was not less than 0.7. Thus, the MTD for micro-surfacing asphalt pavement at the accident-prone areas was complying with the ASTM-E955 standards and demonstrated improved pavement surface friction behaviour.

Figure 12: Results of Texture Depth Tests (before & after) laying micro-surfacing asphalt pavement at the slow lane and fast lane along KM 312.30 – KM 314.10 (South bound)
