# Crash Investigation on Automobile vs. Crash Barrier: Assessment of W-Beam Guardrail with respect to REAM Standard

I. Abdul Hamid<sup>\*1</sup>, S. T. M. Syed Tajul Arif<sup>2</sup>, N. S. Mohd Zulkiffli<sup>2</sup>, R. Sarani<sup>2</sup>,  
M. S. Solah<sup>1</sup> and M. R. Osman<sup>1</sup>

<sup>1</sup>Vehicle Safety and Biomechanics Research Centre, Malaysian Institute of Road Safety  
Research (MIROS), 43000 Kajang Selangor, Malaysia

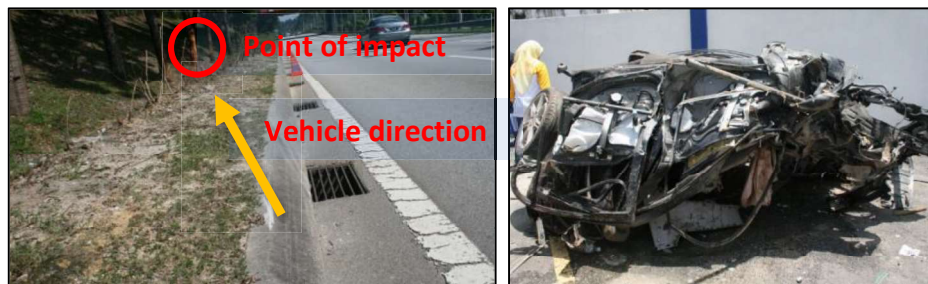
Installation of longitudinal traffic safety barriers along the road sides and medians are very crucial. Unavailability of safety barriers expose the out-of-control vehicles to cross the road sides or median and hit the fixed objects or in coming vehicles from the opposite direction. Figure 1 shows photos from real crash investigation on a SVA involving a passenger car hitting the trees planted along the side of the road. This type of crashes may be prevented if the safety barriers were installed on the road sides.

**Figure 1:** Case study 1 – A passenger car experienced severe damage after hitting a tree

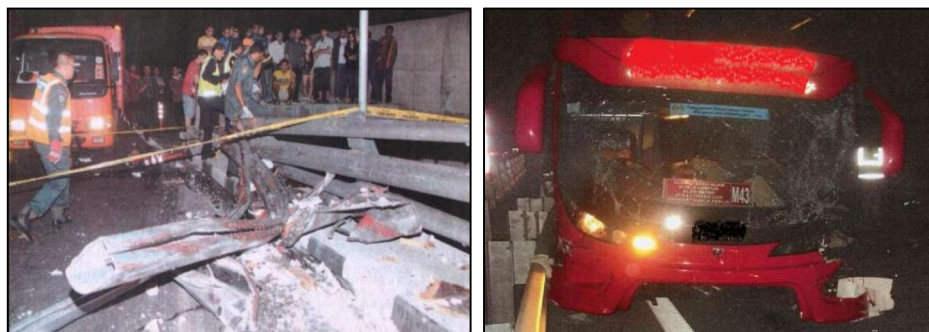
However, the availability of safety barriers may not serve its purpose if it is wrongly installed. Figure 2 shows a SVA involving a bus hitting a semi-rigid guardrail. The poor end-treatment caused the guardrail to pierce inside the lower deck of the bus, killing several people and injured many others.

**Figure 2:** Case study 2 – Semi-rigid guardrail piercing into a bus

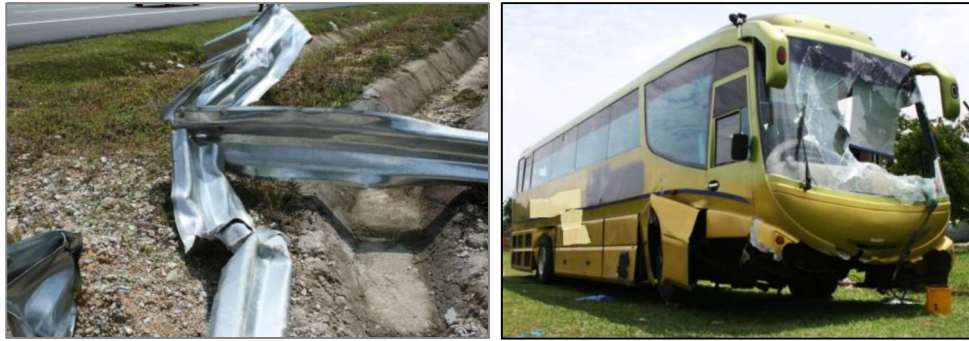
In Figure 3, it shows the W-beam guardrail collapsed after being hit by a bus. Besides compatibility issue, other concerns like the barrier selection, installation procedure and the integrity of the guardrail can also be put into questions.

**Figure 3:** Case study 3 – A guardrail collapsed and failed to redirect the bus

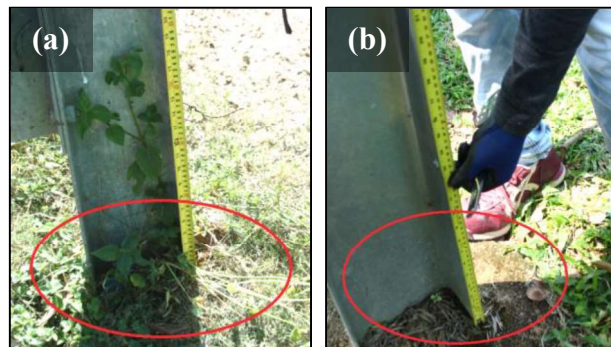
At survey locations, many posts were found installed according to the standard as mentioned earlier. Figure 4(a) indicates the post was installed in the soil to allow it to bend and deflect, whereas Figure 4(b) shows the stiffened W-beam post by concrete. This is because there was a rigid object located less than 1.0m behind the guardrail.

**Figure 4:** (a) Post installed in the soil; (b) Post was stiffened by concreting it

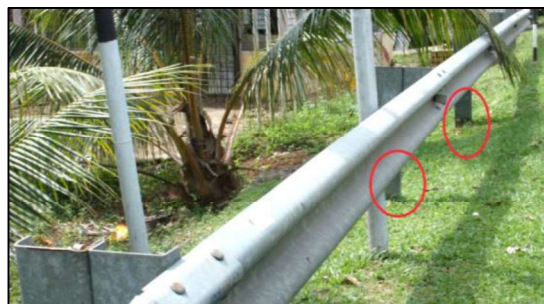
However, survey carried out at rural area found several posts without being concreted even though the rigid objects, e.g. gantry signs, were placed less than 1.0 m behind it (Figure 5). If the vehicle hit the guardrail, it would deflect more and may hit the gantry signs.

**Figure 5:** Fixed object is placed less than 1.0m behind pole without concrete

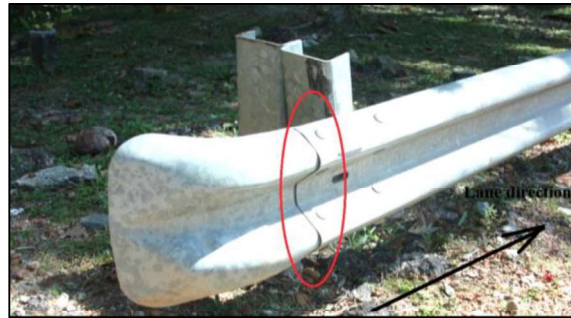
Guardrail panels will be overlapped to join two or more panels. The overlap direction is critical for a safe function of the guardrail. Guardrail could pierce into vehicle compartment if improperly overlapped. Guardrails were found correctly overlapped for all sites except one location at seaside area, where guardrails were found wrongly overlapped (Figure 6). According to the standard, the rails of the incoming direction must be at the front of the next rail. This practise is to avoid ‘spearing’ condition if the overlapping is wrongly installed. This is when the vehicle hitting the first rail while the second rail, be at the front lap, intrude into the vehicle.

**Figure 6:** Wrong overlapping

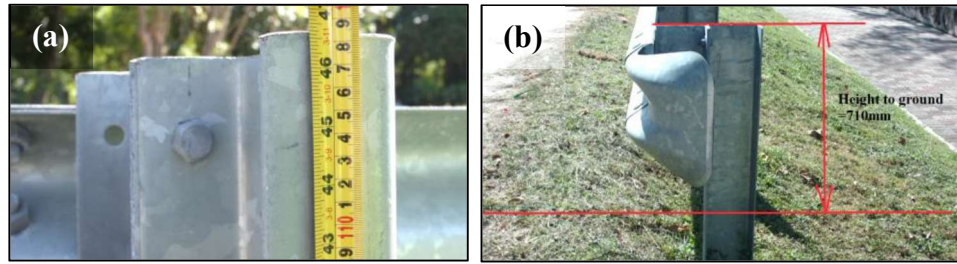
However, if height to ground is considered, many of these guardrails can be considered installed within the tolerance because the ground height (road surface) is usually higher than the post ground. Figure 7(a) shows the post height at the seaside is 1850 mm, but its ground height as shown in Figure 7(b) is 710 mm.

**Figure 7:** (a) Post height is 1850 mm; (b) Height to ground is 710 mm

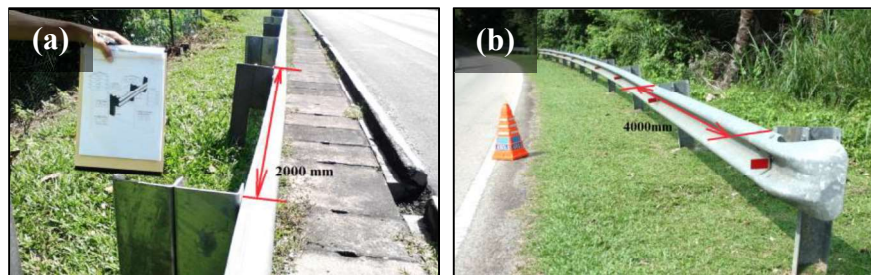
Post spacing depends on the design speed of the road. For expressway, the allowable maximum speed is 110 km/h. Referring to the REAM (2006), for design speed of more than 90 km/h, it is recommended to use TL-3 containment level. For the design speed of less than 90 km/h, the recommended containment level is TL-2. For TL-2, the spacing is 4000 mm while for TL-3, the spacing is 2000 mm. From the survey, it was found that all of the post spacing is in accordance with the standard (Figure 8(a) and (b)).

**Figure 8:** (a) TL-3 with 2000 mm spacing; (b) TL-2 with 4000 mm spacing

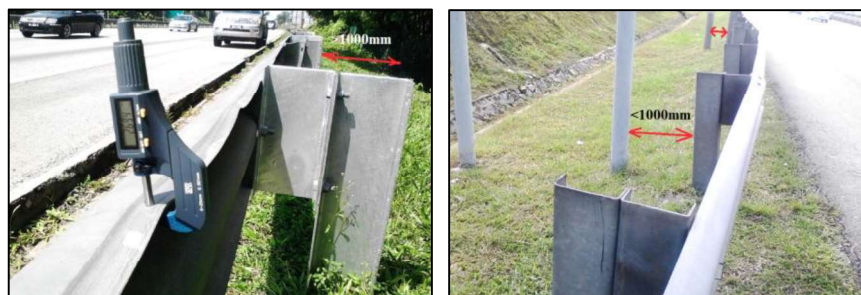
Based on REAM (2006), about 0.6 to 1.0 m clearance is required at the back of the guardrail. Adequate clear zone is vital to ensure that an impacting vehicle will not crash into the hazard with the consequence of injury to the occupants. At the highway, most of the areas provide sufficient clear zone (Figure 9(a)). Only some of the locations where the gantry signs are placed less than the minimum clearance (Figure 9(b)).

**Figure 9:** (a) Clear zone > 1000 mm; (b) Clear zone < 1000 mm

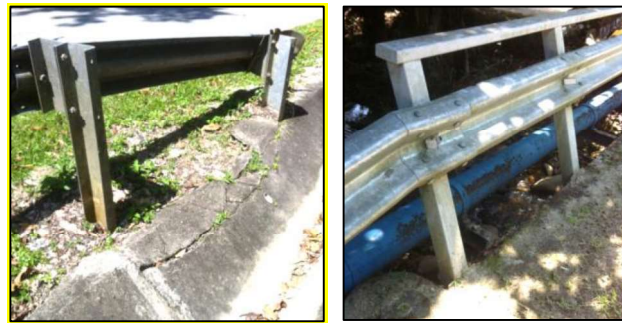
At the highlands, it was found that many guardrails are installed with adequate clear zone. A few cases, like in Figure 10(a), the clear zone is inadequate for drainage, however the posts

have been concreted, hence comply to the standard. In Figure 10(b), pipelines were laid behind the non-standard guardrail and this is not following the clear zone requirement. At seashores, sufficient clear zone is provided as shown in Figure 11.

**Figure 10:** (a) Posts are concreted as  $< 1000$  mm; (b) Pipeline behind the drainage clear zone guardrail with clear zone  $< 1000$  mm

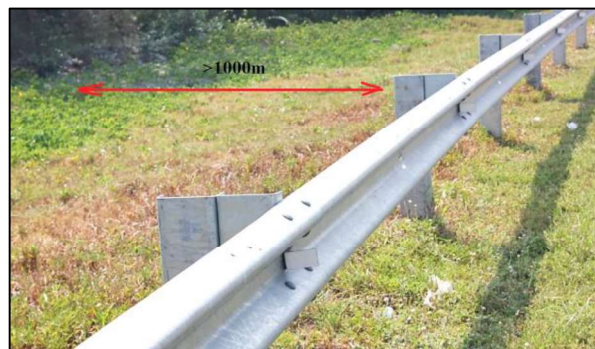
**Figure 11:** Good clear zone at seaside

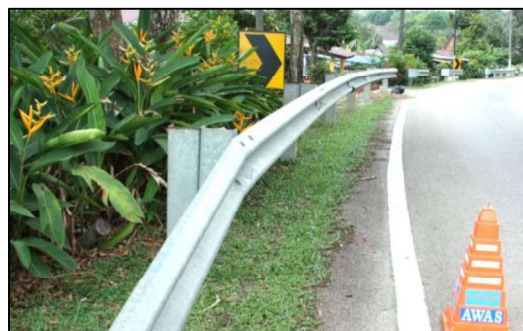
At rural areas, clear zone was narrow because of space limitations. Figure 12 shows the trees behind the guardrails. Clear zone is critical, especially in rural areas where the space is limited and occupied by trees. Other typical obstacles are poles, gantry signage, street lights, etc. Under such conditions, the posts are recommended to be made stiffer (concreted) as stated in REAM (2006).

**Figure 12:** Rural areas have inadequate clear zone

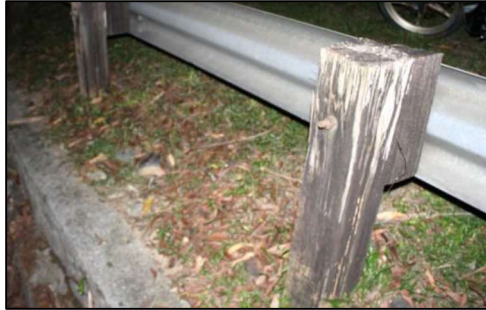
REAM (2006), it was stated that spacers and posts are generally constructed from steel. Concrete posts and timber posts are not favoured because of poor impact performance. However, timber posts were found at city area as depicted in Figure 13. The use of timber posts as in this case may refer to other standards, but as far as the authors are concerned, it is not applicable in Malaysia.

**Figure 13:** Timber posts were installed and used at the city

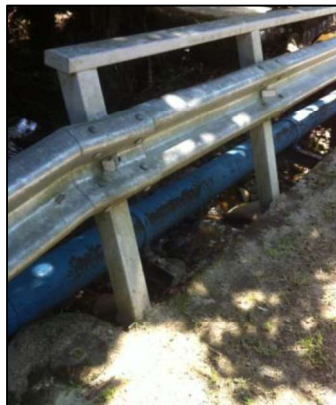
Figure 14 shows non-standard posts used to hold the rail. This square-shaped posts may be used to accommodate the limited space between the post and the blue pipeline stretched behind the guardrail, as the standard post is wider in size. It is unknown whether this practice is tested and acceptable, and it requires further research to verify the practice.

**Figure 14:** Non-standard posts were used to hold the rail

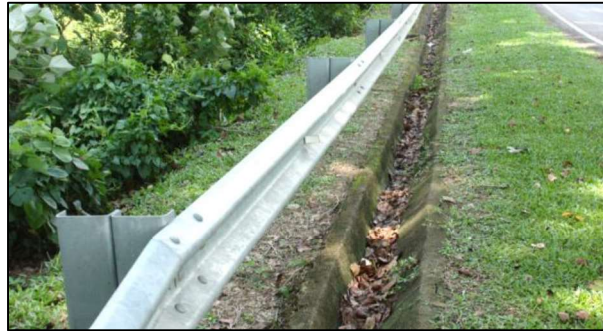
The third issue is objects located in front of the guardrail. The examples are concrete drain and signage. REAM (2006) states that concrete drains need to be a minimum of 600 mm of earth behind the post, as the guardrail requires lateral earth pressure to allow it to bend and deflect. However, it was found at rural area that the concrete drain is at the front of the guardrail (Figure 15). With this substandard installation, the run-off-road vehicles may fall in the drain before it hit the guardrail. This will make the height of the vehicle, especially passenger cars, to be incompatible to the height of the rail. Hence, this creates a greater risk for the rail to hit the passenger's head instead of the door.

**Figure 15:** Concrete drain at the front of guardrail installed at rural area

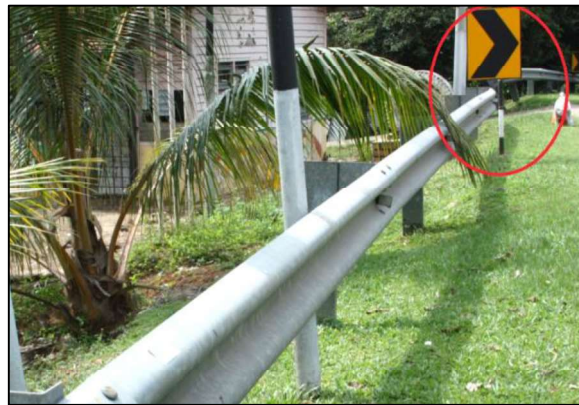
It was found in the survey that some fixed object, e.g. signage was placed at the front of the guardrail (Figure 16). The space at the front of the guardrail should be left clear to allow smooth vehicle deflection in case a crash happened. According to REAM (2006), this is considered as an obstacle and it should be removed or relocate, or be made a breakaway (having

a slip-base), or should be shielded. In this case, it seems none of the recommendations applied. In the case of accident, the vehicle will hit the signage and guardrail will not function properly.

**Figure 16:** Signage is placed in front of guardrail
