Failure Analysis in Vehicular Crash Reconstruction

Malaysian Institute of Road Safety Research (MIROS), 43000 Kajang Selangor, Malaysia

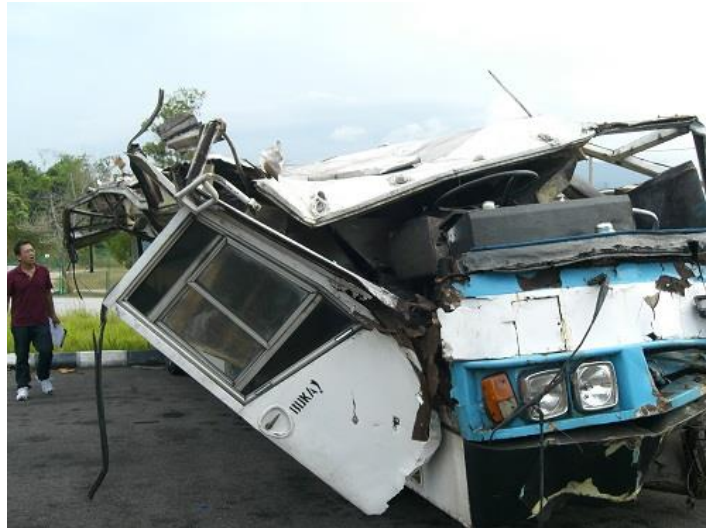
In a single crash that resulted in six fatalities and 25 injuries, a bus ran off-road and punched through a guardrail, collided with a tree stump, and subsequently overturned. The impact caused the entire roof to collapse and flatten the passenger cabin (Figure 3). Inspection of the bus registration history revealed that the vehicle was already 16 years old, and the structure was found to be severely rusted (Figure 4). Further examination revealed that one of the significant factors contributing to the structural failure was the highly deteriorated roof structure material. The manufacturer welded the pillars together instead of using a continuous ring system (Figures 5 - 7). The welded sections have been determined to be the weakest area, thus serving as the undesired failure modes during the crash.

FIGURE 3: Bus roof that collapsed and flattened the passenger cabin

As for the third objective, to determine, for each component or structure found to be broken (cause), whether it did produce the observed injury (effect), we can take the example of the bus cabin structural failure, which resulted in the complete collapse of the roof assembly. Evidence at the crash scene showed many occupants had been trapped under the roof, and the injury details confirmed that a high number of the occupants had suffered crushing injuries. Had the superstructure persisted and withstood the crushing impact, the bus occupants would have had higher chances of survivability. A properly designed superstructure should be safe even if it is put under excessive stress. It should be able to support its weight while enduring external forces that could lead to deformation, breaking, and catastrophic failures of the structure under duress. As a result, the occupants would be protected within this "survival space", especially during rollovers. Thus, passengers are less likely to be fatally crushed by the roof.

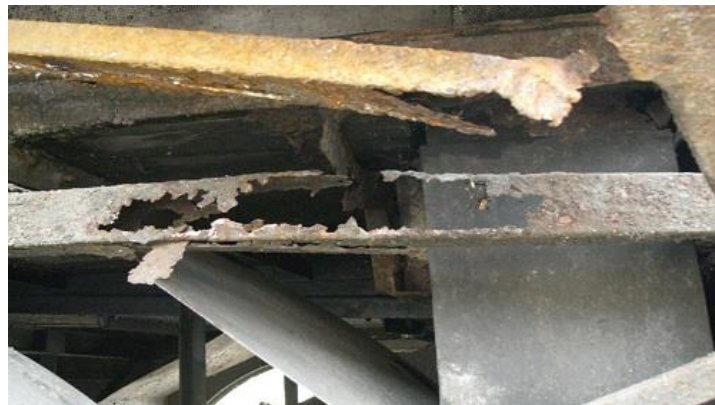
FIGURE 4: Severely rusted structures

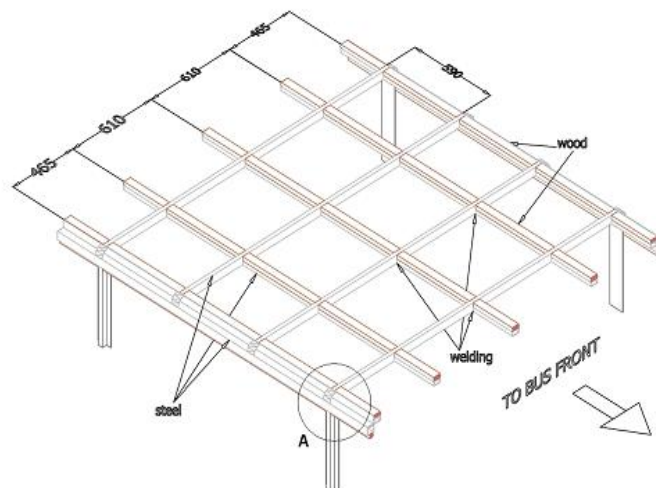
FIGURE 5: The manufacturer simply welded parts together to connect the pillars

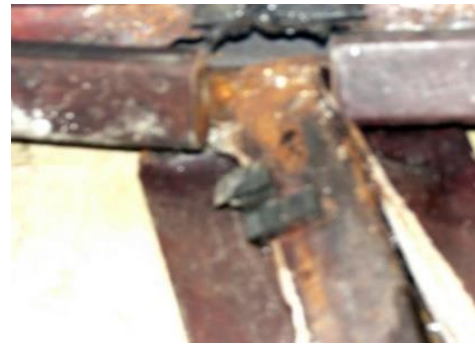
FIGURE 7: Rusted structure at the welded section

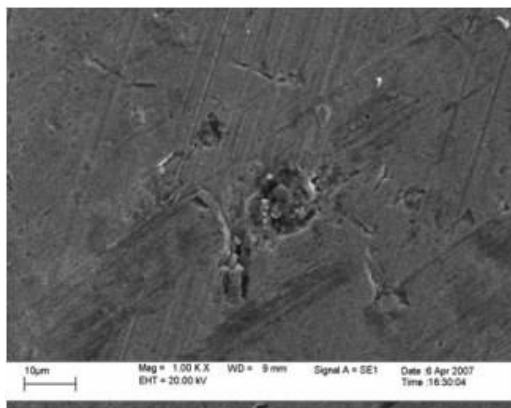
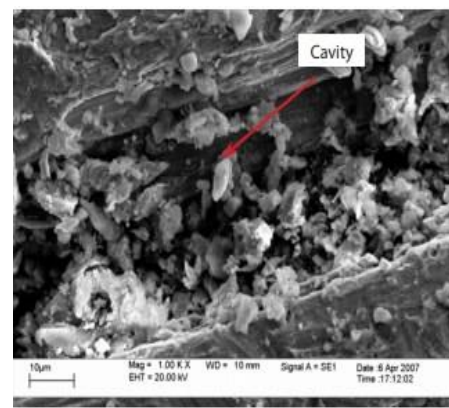
An in-depth material analysis using a Scanning Electron Microscope (SEM) revealed that the bus superstructure was constructed using cast iron (Figures 8 and 9) instead of high-carbon steel. In this case, it can be suspected that the lower-quality material is used to save manufacturing costs. Additionally, there is no evidence of any rust preventive coating having been applied to the bus structure.

FIGURE 8: SEM image of a sample from the bus superstructure

FIGURE 9: Grain structure of sample from the bus superstructure

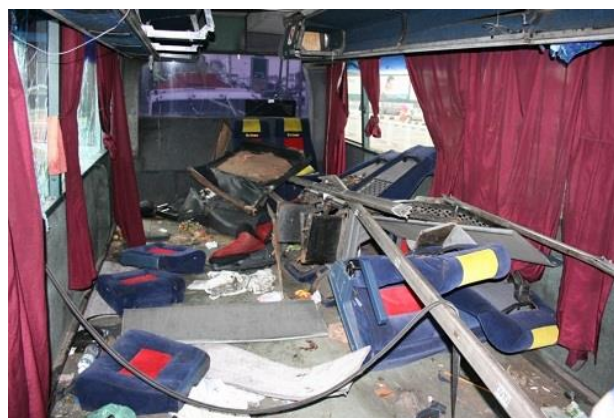
In a different incident involving a bus, 8 out of 33 occupants died when the bus collided with the rear end of a tanker. The leading cause of the crash was brake failure when the bus was traveling downhill. Furthermore, the inadequate structural integrity of the bus played a role in exacerbating the severity of fatalities and injuries. The steel structure of the bus exhibited significant rusting, and the seat anchorage was identified as notably weak. The coachbuilder used screws and bolts to attach the seats to the bus floor, which consists of plywood with a reinforced wood structure. Figures 10 and 11 show the typical anchorage failures in the bus. Only four seats remained attached to the floor, and even those had gone loose.

FIGURE 10: Improper seat design and anchorage caused seat detachment upon crash

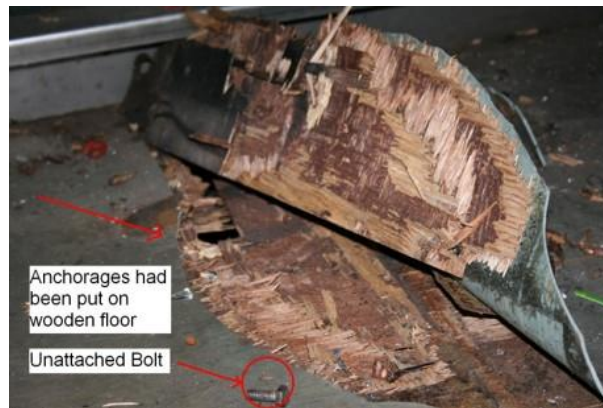
FIGURE 11: Floor made of plywood unable to secure seat anchorage

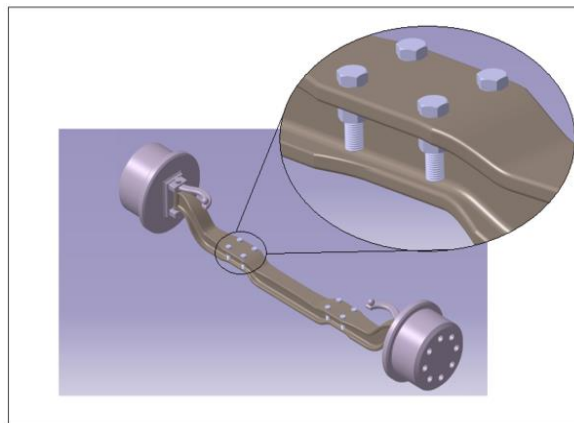
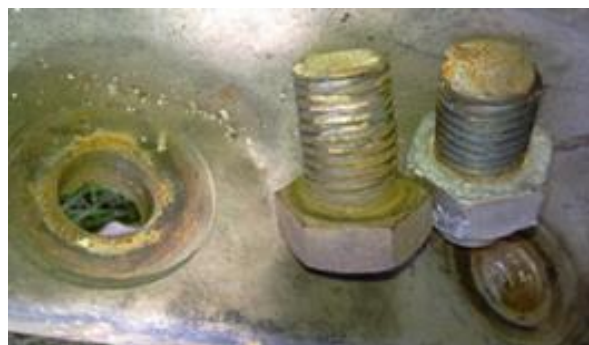
It is typically uncommon for a vehicle axle to become detached in a crash. However, in a notable crash case examined by MIROS, the front axle of a bus separated upon colliding with a concrete barrier. According to the analysis, the detachment resulted from the failure of high-tensile bolts that connected the axle to the front suspension assembly, as depicted in Figures 12 and 13. The bolts that failed, retrieved from the bus axle and the crash site, underwent examination using a Scanning Electron Microscope (SEM) and Energy Dispersive X-ray (EDX) to ascertain the primary mode of failure, the bolt's base material, and its overall quality.

FIGURE 12: Close-up front axle with bolt location

FIGURE 13: Two high tensile bolts for axle connection found at the site

The examination findings reveal that the failure of the axle bolts was a result of multiaxial tensile and shear loads from the impact. The EDX analysis indicated that the bolts had a non-standard material composition, with unusually elevated Carbon (C) contents compared to the standard cast iron composition. Additionally, the presence of voids in the bolts contributed to internal stress concentration on the microstructure, ultimately leading to failure.

A comparative analysis was also conducted using an original bolt obtained from the chassis manufacturer. Upon comparing the results with the failed bolt, it was determined that the crashed bus had replaced the original with substandard, lower-grade axle bolts. The noticeable disparity between the original and the failed bolts underscores an inappropriate choice of fasteners for the axle, a component of paramount importance in a vehicle. The use of substandard components in such critical subsystems should be prohibited, as their failures have the potential to escalate into catastrophic consequences.

In the context of the first objective for crash reconstruction, determining whether component failure caused the crash, the case of the detached axle shown in Figures 12 and 13 reveals that the front axle of the bus came off and separated from the bus ladder frame upon impact, not before the collision with the concrete barrier. Road evidence, such as visible skid marks within the crash radius, should be regarded as primary evidence. Skid marks play a crucial role in vehicular accident investigations, as their characteristics and types enable forensic scientists and engineers to accurately determine the pre-crash and post-crash condition of the involved vehicle through trace evidence analysis. Upon a thorough examination of the bus collision in the case study, the skid marks on the roadway provided clear evidence that the front wheels were still attached to the vehicle before impact. This alignment corresponds to the tire skid marks on the roadway leading into the median concrete barrier. Based on these observed pieces of evidence, it can be concluded that the front wheel axle must have detached upon impact and not before. If the front axle had separated from the bus before impact, the skid marks would have exhibited rougher characteristics, including metal grazing and deep pavement scarring on the road surface, as the bus slid forward on its metal frame.

Regarding the second objective of crash reconstruction, which involves determining the primary cause of an identified failure, the examination of the axle that separated from the bus revealed that the detachment occurred because the bolts and fasteners, serving as anchorage points between the wheel axle and the main chassis, failed to withstand the excessive impact force during a crash. Material tests conducted on both the failed and original bolts indicated that substandard lower-grade axle bolts had been substituted for the higher-performing originals.

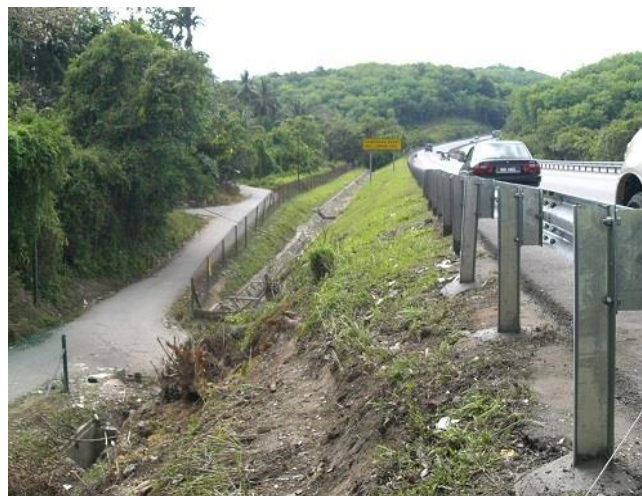
In numerous instances, there was also improper installation of crash barriers, impacting their performance during collisions, notably affecting the designed collapsing mechanism for the barrier system. In the specific case where the bus punched through the guardrail, slid down a slope, and overturned, the inadequate provision of a dynamic deflection zone behind the guardrail was the contributing factor (Figure 14).

FIGURE 14: Inadequate dynamic deflection zone behind the guardrail

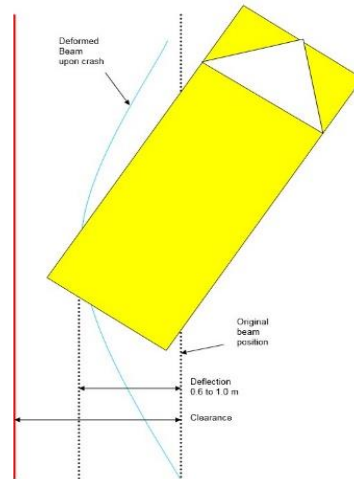
The guardrail posts positioned close to an embankment slope lacked the strength required to withstand the impact of the bus. As depicted in Figure 15, a deflecting guardrail is intended to redirect a runaway vehicle back onto the road, enabling the driver to regain control. However, in this particular case, even if the guardrail had been correctly installed, it likely couldn't deflect the bus as it was not designed to contain such large vehicles. The most suitable barrier system for containing heavy vehicles should undergo crash testing to meet Test Level 6 standards.

FIGURE 15: A deflected guardrail should divert the run-off vehicle back onto the road

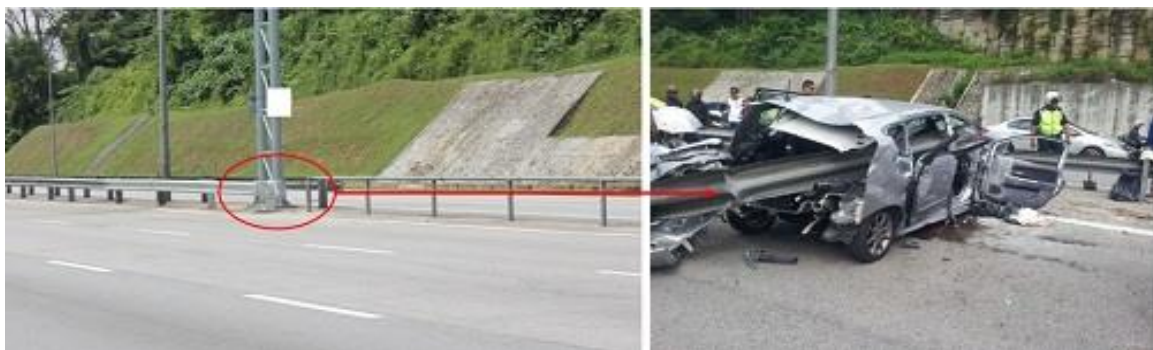
Moreover, inadequate end-treatment of the guardrail presented a threat to the passing vehicles. According to cases investigated by MIROS, the protruding end of the guardrail led to instances where errant vehicles were pierced by the rigid panel, resulting in severe injuries to the occupants (Figure 16). These protruding ends are typically found in the gap section between median guardrails. In another incident, improper end-treatment of a bridge barrier resulted in the bridge railing penetrating the bus's passenger compartment, causing fatal injuries to ten occupants (Figure 17). An examination of the site revealed that the bridge barrier was not installed in compliance with standards. The end treatment of the bridge should have been installed flush and aligned with the concrete barriers to prevent any hazardous protrusions.

FIGURE 16: The protruding end of the guardrail penetrated the car

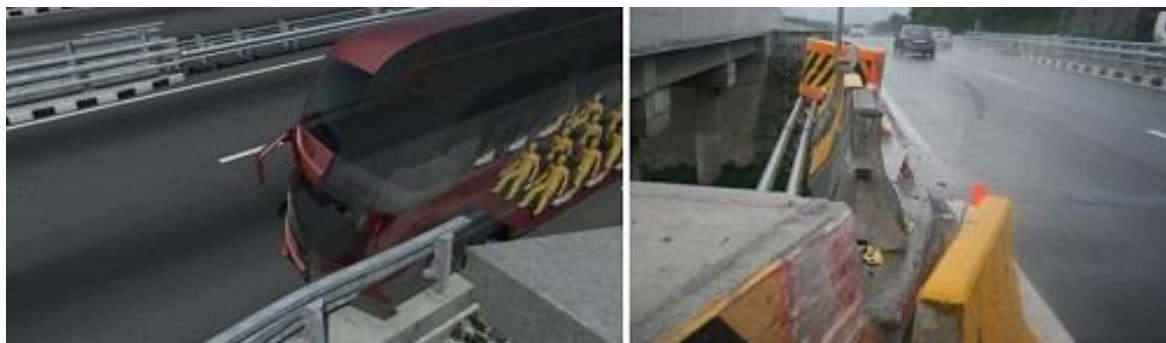
FIGURE 17: The bridge railing penetrated the bus passenger compartment

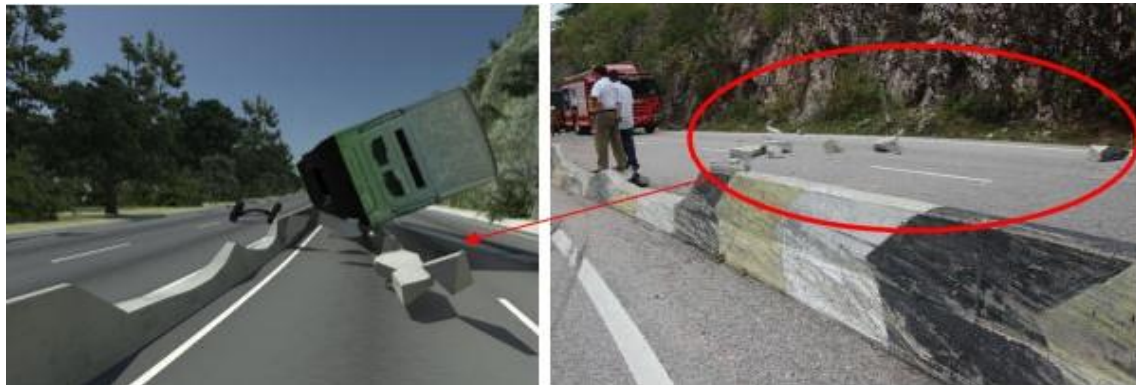
In one of the cases investigated by MIROS, the median concrete barrier failed upon impact by a bus. Instead of effectively preventing the bus from crossing into the opposite lane, the barrier shattered into pieces (Figure 18). The site investigation revealed that the barrier adhered to the dimensions of the Test Level (TL) 5 New Jersey Concrete Barrier (NJB) but lacked the necessary reinforcement bars. While concrete is a material highly resistant to compression forces, it is weaker against tensile forces. By incorporating steel rebars, a material with high tensile strength, into the concrete, the structure would have exhibited robust resistance against both compression and direct tensile actions. Strengthening the concrete barrier in this way would have prevented it from easily breaking apart and effectively halted the bus from penetrating through into the opposite lane.

FIGURE 18: The barrier was broken into pieces from the impact and failed to stop the bus from launching into the opposite lane
