ASEAN NCAP's Study on the Effectiveness of Passenger Car Blind Spot Technology (BST) to Detect Motorcycles

Keywords: Blind Spot Technology (BST), active safety, ASEAN NCAP, target vehicle (TV), subject vehicle (SV)

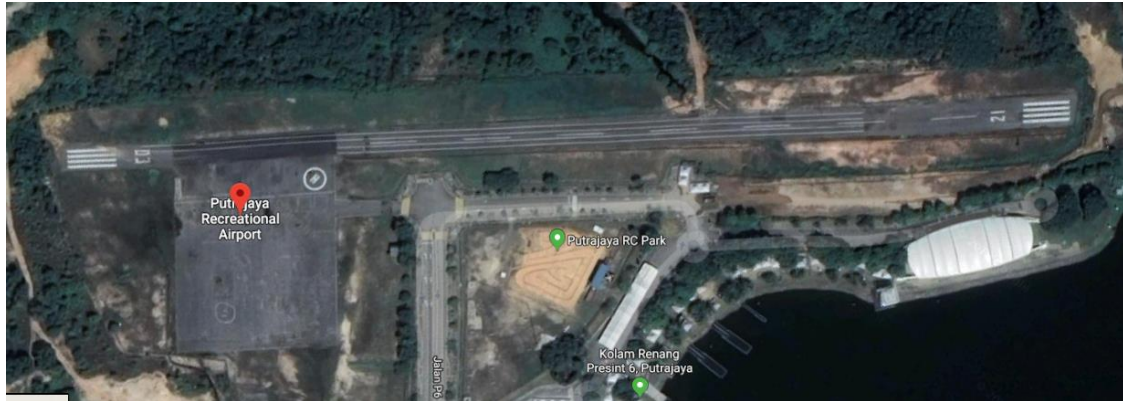
Figure 4: Ariel view of Putrajaya Recreational Airfield

The testing area is very important and it needs to have flat, dry asphalt or concrete surface. The place identified for this research was the Putrajaya Recreational Airfield (see Figure 4), where the airstrip is 637 metres (length) \times 21metres (width) (the area size is 702,793.5 ft. sq.). Figure 5 shows the arrangement made for the test.

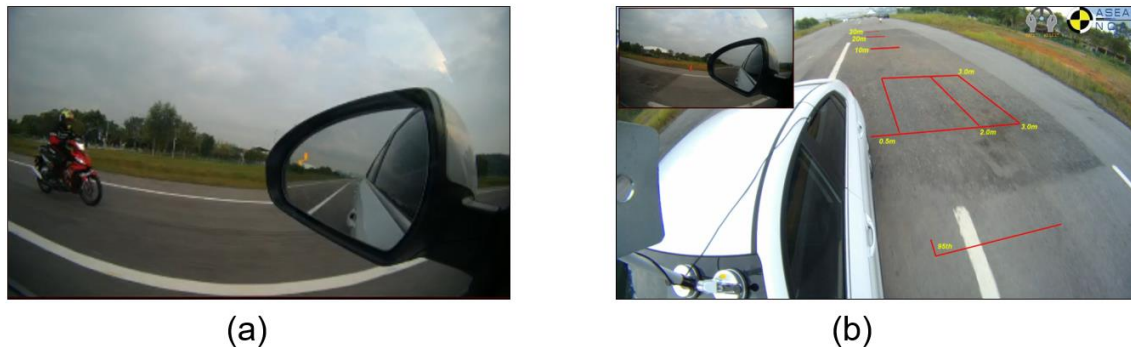
Figure 11: (a) From inside view; (b) Top left side view

The BST was verified using the recording video database taken by VBOX camera containing two viewing display from the top left side of the car and inside the car for the blind spot monitoring warning as shown in Figure 11. The two views in the video recording had the same speed and time, showing the BST warning light or indicator at the same time and indicating the position of TV.
