Driver's Injury Severity in Light N1 Vehicles Derived from Crash Test

M. H. Johari^{*1,2}, Y. Ahmad², S. S. S. Zainuddin³, J. M. Jyothesh⁴, N. K. Khamis¹ and M. R. A. Mansor¹

ABSTRACT – Light N1 vehicles, also known as Light Commercial Vehicles (LCVs), of two types are being considered for this study: panel vans and small lorries. This paper presents the causes of driver injury in light N1 vehicles derived from official ASEAN NCAP crash test data. Companies employ all sorts of vehicles to help expedite the delivery process, but having considered the large amounts of orders globally, keeping costs low is also of top priority. To overcome this problem, companies now employ the use of LCVs, which not only are smaller in size allowing them to maneuver through small lanes easily but are relatively inexpensive to run in comparison to their larger counterparts. LCVs fall under the N1 category of vehicles which is an EU classification of vehicles that are used to carry goods of maximum mass not exceeding 3.5 tons and they commonly can be found carrying goods either on the exposed cargo trunk or within a compartment at the rear of the vehicle. However, the structural integrity and crashwo

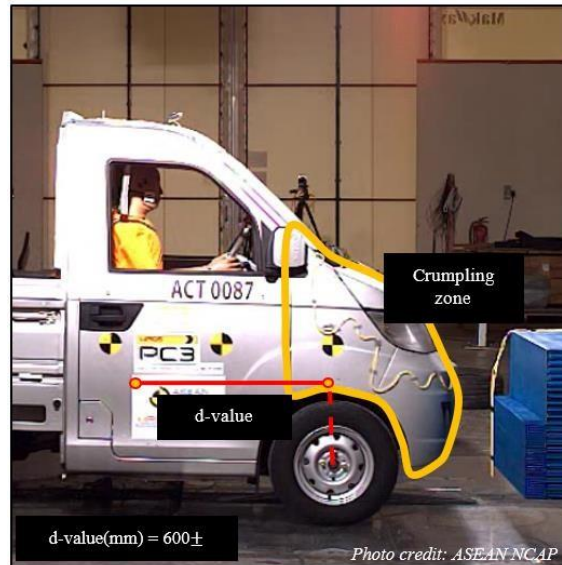
FIGURE 2: Pre-crash image of Chery Transcab

Chery Transcab falls under the category of small lorry/truck, it functions as a goods carrier and could also be used to carry passengers. The Chery Transcab is designed with an open rear trunk, like that of pick-up trucks, to allow better utilization of space to carry cargo. Figure 2 shows the vehicle and the position of the dummy before the impact. Through observation, the horizontal distance between the front axle and the driver's seat R-point is approximately 600±mm. From a visual inspection standpoint, the crumple zone (yellow region) seems inadequate to effectively distribute energy throughout the vehicle and protect the occupants during frontal collision.

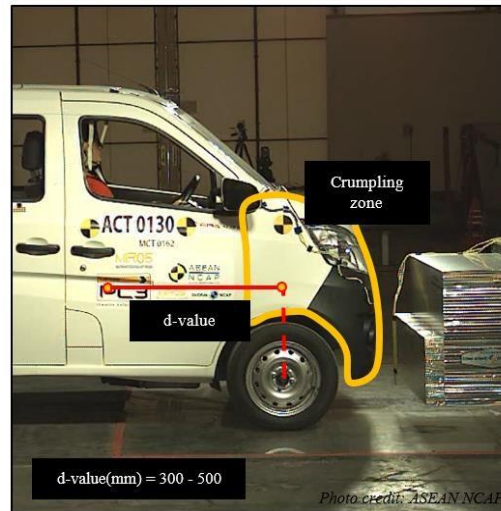
FIGURE 8: Pre-crash image of Chana Era Star II

Chana Era Star II is a semi-panel van that was built and produced in the year 2019. This vehicle does not come with airbags and does not have any other safety assist technology such as Antilock Braking System (ABS) or Seatbelt Reminder (SBR). Figure 8 shows the design of the vehicle's frontal structure before the impact. The 'd-value' of Chana Era Star II was measured to be between 300mm to 500mm while the crumple zone had been indicated with the yellow line.
