Effects of Shelf Age Based on Types of Approval Marking on Passenger Car Tyres' Safety Performance

Keywords: Passenger car tyres, accelerated ageing, Design of Experiment, performance test, shelf age

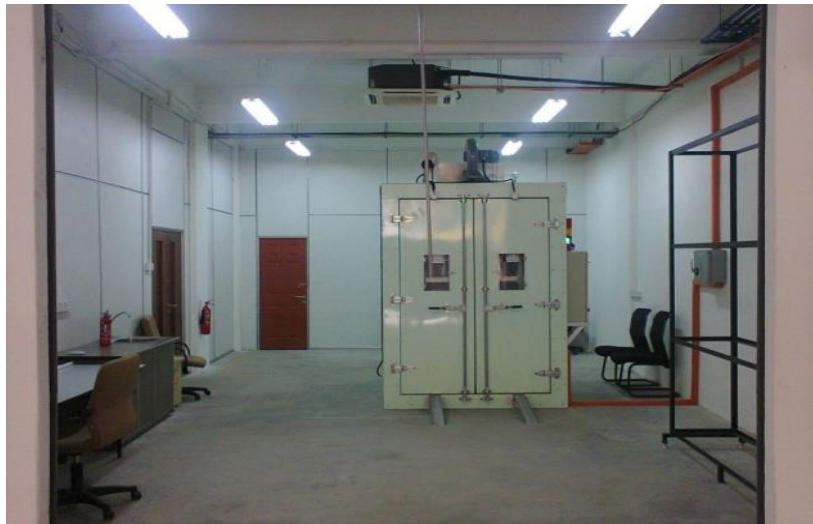
An ageing chamber shown in Figure 1 was used to simulate the environment with the desired climate conditions for accelerated tyre ageing process in this study. The protocols for the accelerated ageing tests were based on two available and relevant standards during the time which were as follows:

The ageing chamber was installed with multiple instruments to enable control of climatic conditions in the chamber. The concept for the chamber was developed by MIROS research team through numerous discussion sessions with tyre experts and academics in regards to polymer and vulcanized rubber products. The final technical specifications selected for the ageing chamber were as follows:

- i. Machine Name: Accelerated Ageing Chamber
- ii. Size (W x D x H): 1702mm x 2115mm x 3051mm
- iii. Voltage (V) / Phases: 415±10% AC / 3 phase
- iv. Frequency (Hz): 50/60
- v. Mains Fused (A): 100
- vi. Max Operating Temperature (°C): 110
- vii. Capability: 6 units of passenger car tyres per batch
- viii. Safety Features: sensors with PLC control, siren & light tower signal

Figure 1: Accelerated ageing chamber

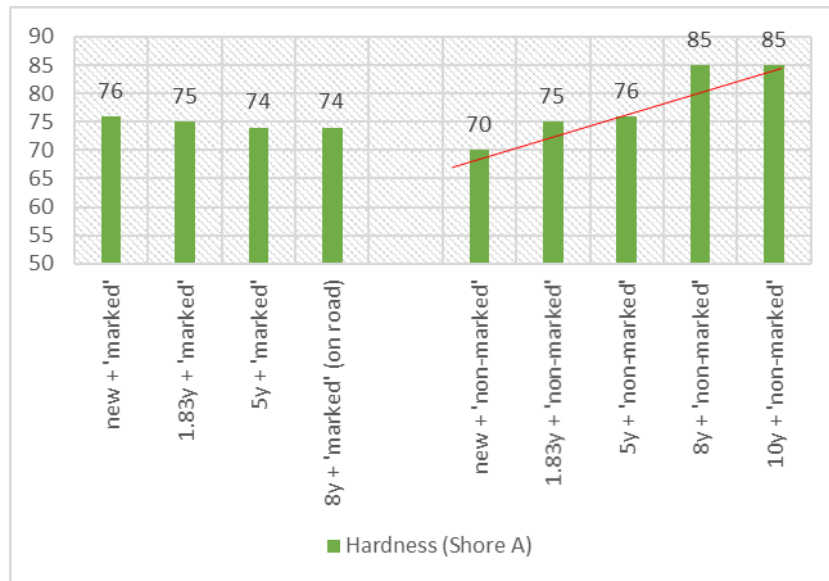
Figure 3: Changes in tyre hardness (Shore A) value with age

First the study looked into the hardness of the tested tyres, represented by the Shore A value, as shown in Figure A. The study found an apparent different trend between the ‘Marked’ and ‘Non-marked’ tyres in terms of Shore A value for the new and aged tyres for both categories of tyres. Analysis on the test results have shown that tyre samples from the ‘Marked’ category showed constant hardness value for both new and aged tyres. Furthermore, even after eight years of on-the-road usage, tyres from the ‘Marked’ category still showed no significant change in terms of hardness, as reflected by their Shore (A) hardness of 74.

However, in contrary, tyres from the ‘Non-marked’ category was observed to have an increasing trend of hardness value by the increasing age of the tyres. The test revealed that the hardness of tyres in the ‘Non-marked’ category increased by 8.5% after accelerated ageing simulating 5 years of normal ageing. Meanwhile, the ‘Non-marked’ tyres with 8 and 10 years of on-the-road usage reached a Shore (A) hardness of 85, which was the highest among all tyre samples. In regards to tyre safety, previous literature has often related tyre hardness increase with the decrease of tyre grip and traction performance on the road (Rex Gauge, 2014; Malaysian Standard, 2008; Federal Government Gazette, 2012; Klein & Black, 1999). Thus, as shown by the test result in Figure 3, the increase in tyre age could play a contributing effect towards the may grip and traction performance of the ‘Non-marked’ tyres as compared to the ‘Marked’ tyres.

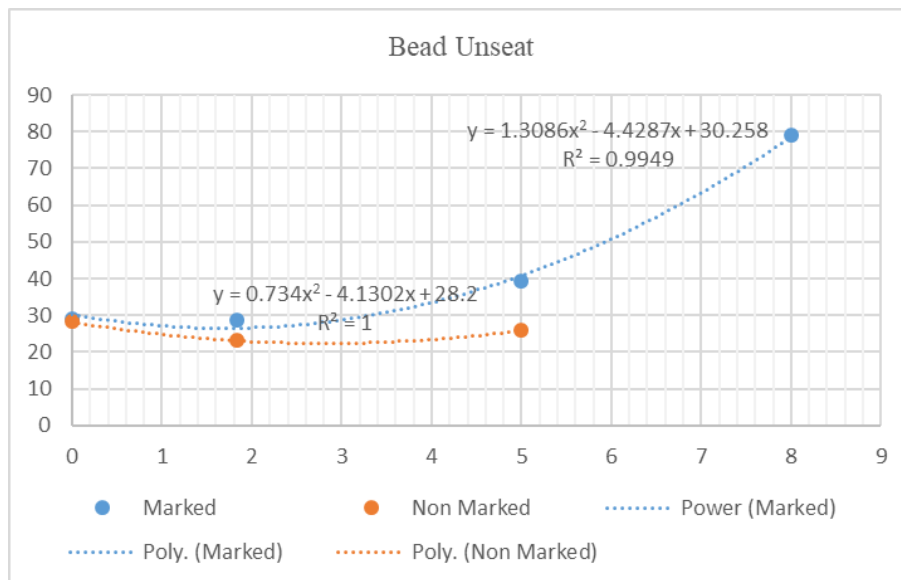
Bead unseat tests were conducted to study the tyre resistance to bead unseating. During the tests incremental forces were applied until the bead was unseated. The graph in Figure 4 shows the performance of ‘Marked’ and ‘Non-marked’ tyres during bead unseat tests in a quadratic polynomial trend, where Y-axis represents the percentage of clearance above minimum loading requirement (910 kgf) while the X-axis represents the year of the tyre. From the graph, the values of loading to unseat the bead for ‘Marked’ tyres were slightly higher than ‘Non-marked’ tyres, particularly for new and 2-year old tyres, as shown from the graph. The difference in terms of performance is found gradually increased throughout the years as shown from the trend line. This indicates that the ‘Marked’ tyres have superior performance than ‘Mon-marked’ tyres for bead unseating tests.

Figure 4: Bead Unseating Test result by tyre category

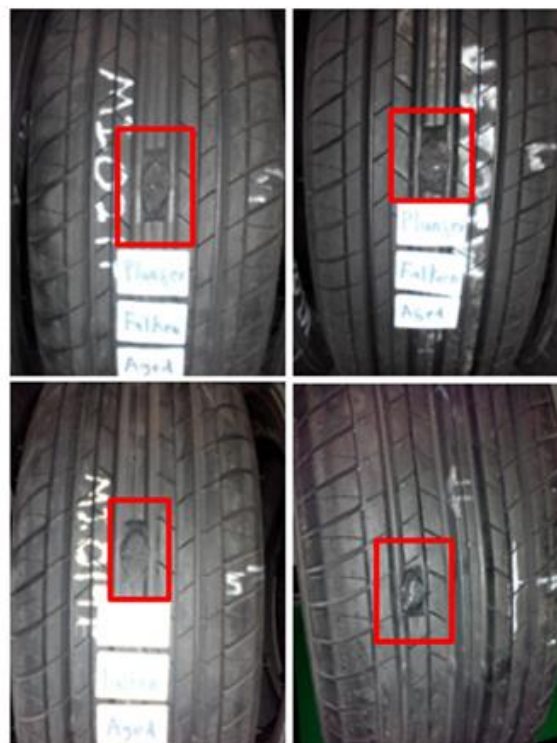
It was noted that all aged ‘Non-marked’ tyres showed a similar type of failure- tread chunking (see Figure 6). One of the causes of tread chunking is the built-up of excessive heat on tyre during the ageing process (Malaysian Standard, 2008). Thus, tread chunking may indicate that ‘Non-marked’ tyres had poor heat build-up resistance as compared to ‘Marked’ tyres. However, the damage carried a minor weighting in the post-test evaluation and the tyre samples were still considered as having passed the plunger test based on the current practice at the testing facility and by the certification body. The results showed that 5-year old ‘Non-marked’ tyres failed the plunger test and possessed physical defects (tread chunking).

Figure 6: Tread chunking on ‘non-marked’, aged tyre samples

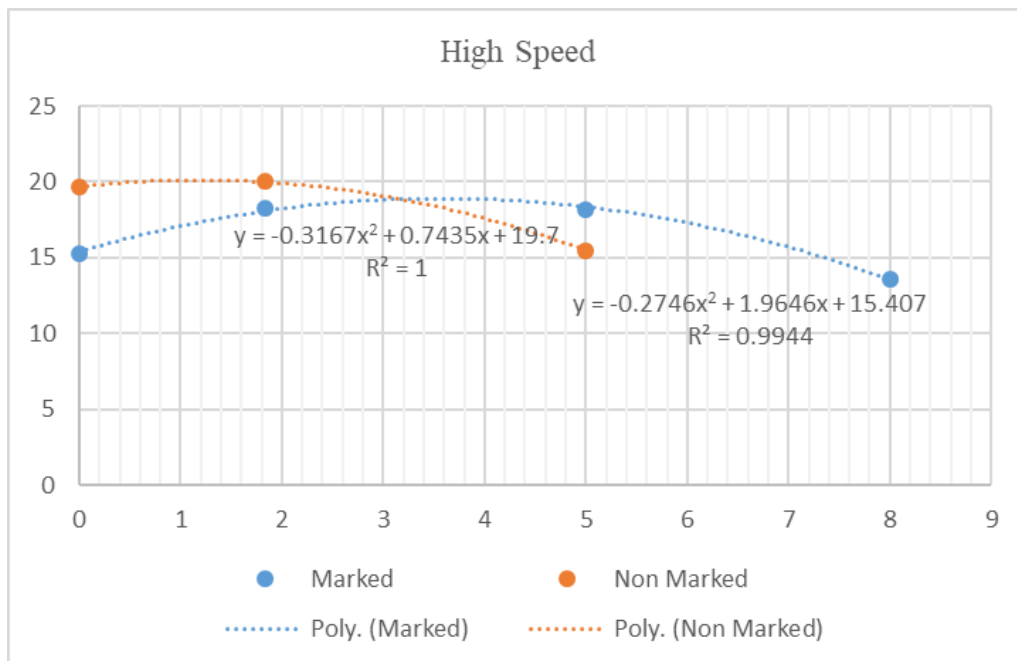
In the high speed tests, the tyres were subjected to high speed performance test and had to meet the following criteria; no visual evidence of physical defects and the pressure at the end of the test must not be lower the initial pressure of 220 kPa.g. From the Quadratic Polynomial graphs of both group of tyres, it can be seen that all tested tyres passed the minimum requirement (post-test pressure higher than initial pressure). ‘Marked’ tyres showed that degradation point occurred at tyres aged 3.6-year-old tyres while the ‘Non-marked’ tyres showed an earlier degradation point of approximately 1.2-year-old tyres (refer Figure 7). The degradation point is an indicator for air permeability of the tyres.

Figure 7: High Speed Test result by tyre category

From the polynomial graphs, the slope of the graph where $dy/dx = 0$ points are being referred. These points signify the deflection point or in other words the Performance Degradation Indicator (d) of the tyres. Results from two tests, specifically the Plunger Test and High Speed Test were observed. As shown in Table 4, from both of the tests performed, ‘Marked’ tyres show higher test result which reflects a superior performance as compared to the ‘Non-marked’ tyres. ‘Marked’ tyres had a 5-year-old degradation point in Plunger Test compared to ‘Non- marked’ tyres which were found degraded at 2 years old in the similar test, while the ‘Marked’ tyres had a 3-year-old deflection point in High Speed Test compared to only a 1-year-old degradation point for ‘Non-marked’ tyres in the same test. In overall, the results show that ‘Non-marked’ tyres display faster degradation point in terms of the year of the tyres for both of the test results. Nonetheless these figures serves as key indicators of the tyre performance deflection point, which may serve as beneficial guidance for predictive maintenance.
